ROYAL AUSTRALIAN AIR FORCE

AIRCRAFT RESEARCH AND DEVELOPMENT UNIT

TECHNICAL INVESTIGATION NO 778

EVALUATION OF NEW IROQUOIS TORQUEMETER PN 73-30-1

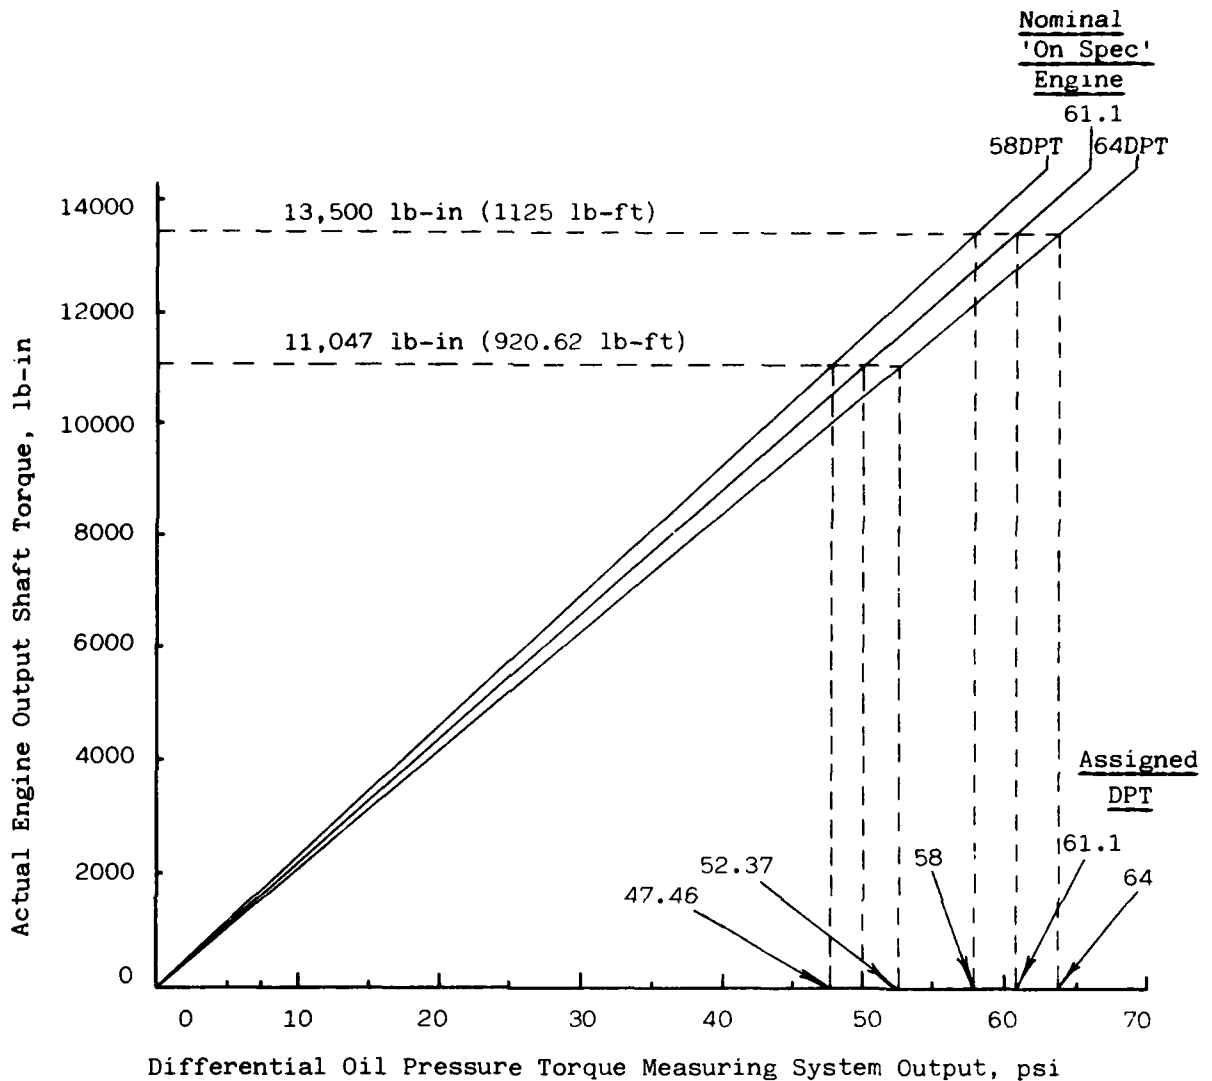
FIGURE 3.1 - DIFFERENTIAL OIL PRESSURE VS ACTUAL TORQUE

- a. Differential Oil Pressure Versus Actual Torque. Differential oil pressure versus actual engine torque is assumed to be linear over the range and to converge on the origin for different DPT engines. This is illustrated in Figure 3.1.

- b. Adjustment At 11,047 lb in Actual Torque. Given the linear relationship illustrated in Figure 3.1, at 11,047 lb in actual torque (the transmission limit equivalent to 50.0 psi torque for the nominal 'on specification' 61.1 DPT engine) the 64 DPT engine produces a differential oil pressure of approximately 52.37 psi (ie 2.37 psi in excess) and the 58 DPT engine produces approximately 47.46 psi (ie 2.54 psi low). A reasonably correct indication should be obtained by adjusting the cockpit indicator up 2.54 psi for a 58 DPT engine, down 2.37 psi for a 64 DPT engine and zero for the 'on specification' 61.1 DPT engine. Annex B, Figure 1 is based on this logic.

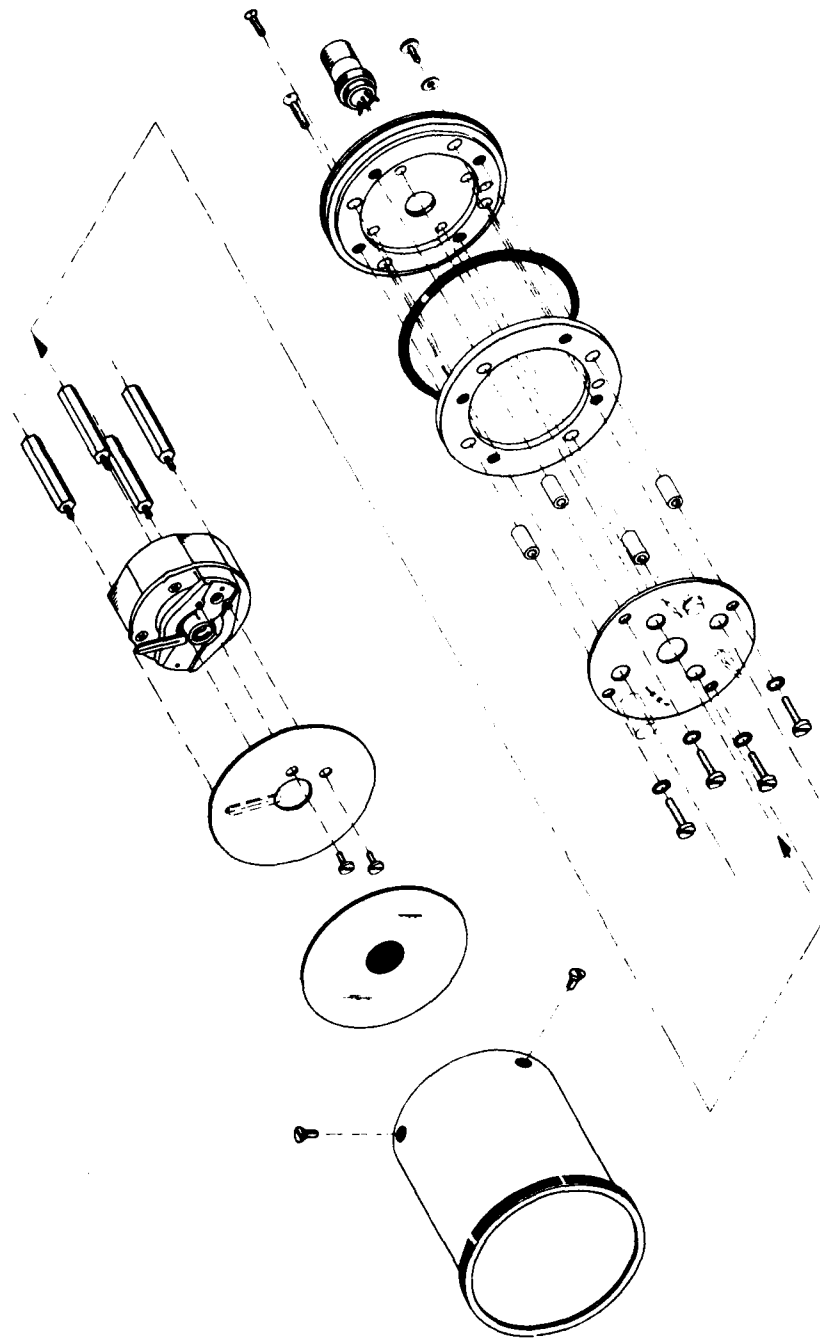
FIGURE 2 - EXPLODED VIEW OF TORQUEMETER PN 73-30-1

Tests showed that torquemeter accuracy was unacceptable and the indicating system was prone to significant drift. Tradesmen found adjustment of the 'zero set' difficult to perform due to poor access to the adjustment screw. Instrument markings in the range greater than 30 psi were obscured when viewed from the co-pilot's seat. The night-lighting of the instrument and the reflection characteristics of the glass cover were also unsatisfactory.

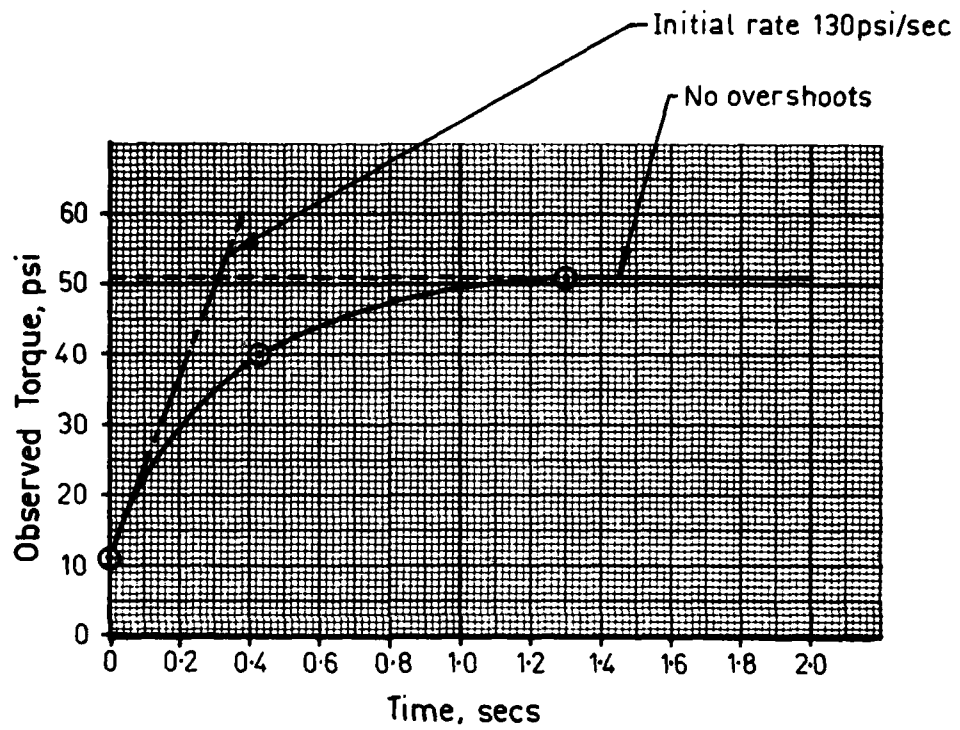
FIGURE 4 - INSTRUMENT RESPONSE TO STEP INPUT

3.2.1 The sensitivity and damping of the instrument were evaluated by making step voltage inputs between equivalent observed torque values of 10.2 psi and 50.2 psi. The times for the needle to pass 40 psi and reach 50.2 psi were recorded for approximately ten runs and then averaged. A rough time history of indication was then reconstructed as shown in Annex A, Figure 4. During these tests, the needle did not overshoot the 50.2 psi reading, showing that indication system damping was critical or higher. Initial needle movement rate was calculated as approximately 130 psi/sec, 40 psi was passed at 0.43 sec and 50.2 psi was reached in approximately 1.3 sec. The Lycoming T53-L-13B engine normally accelerates from idle to maximum engine speed in approximately 2.5 sec.

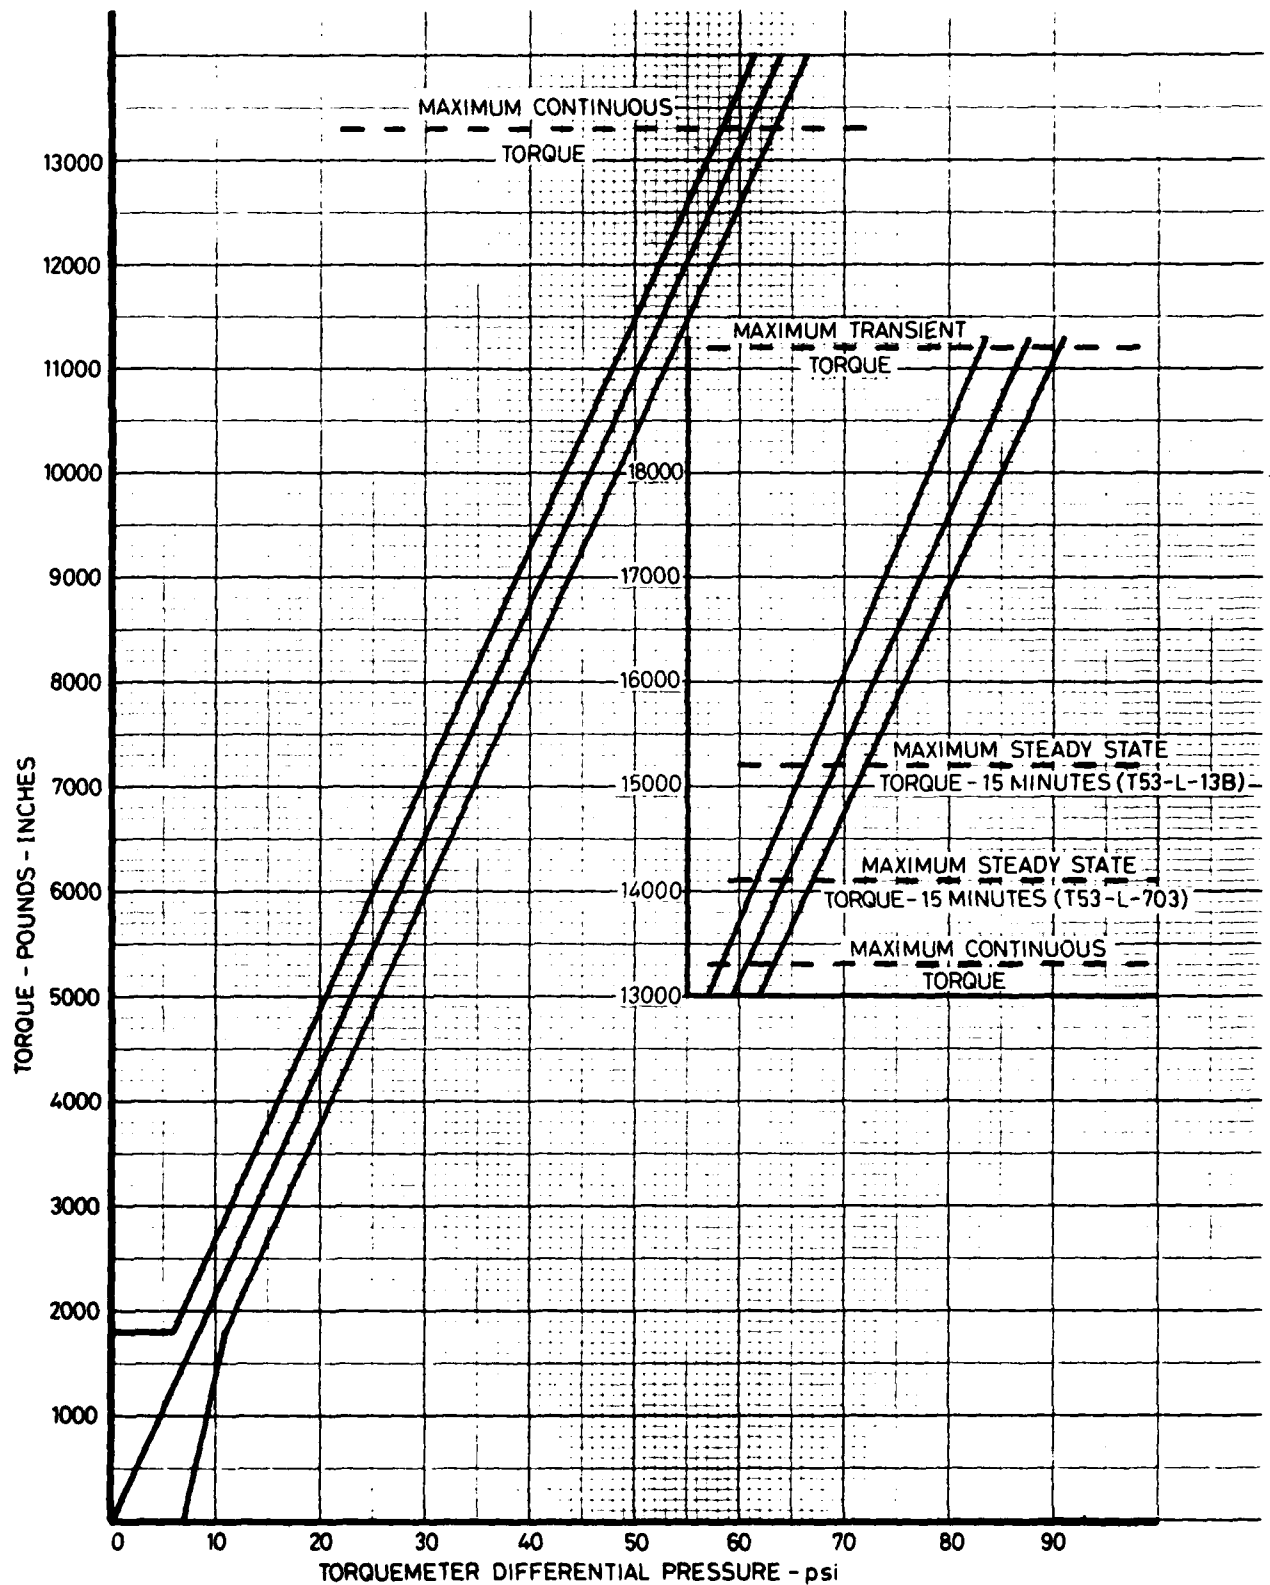
FIGURE 5 - TORQUEMETER ACCURACY LIMITS (T53-L-13B)

- a. the correct test technique had been employed at ARDU, and
- b. instrument error over some sections of the range was greater than the accepted tolerance of ± 1 psi and the instrument would normally have been the subject of a defect report.
